**Flood Control Project Maintenance
Levee Inspections****LMA District Cover Sheet
Spring 2014 Levee Inspection Results****Sutter Maintenance Yard Murphy Slough at M&T Ranch**

Spring 2014 Levee Inspection Results

Sutter Maintenance Yard Murphy Slough at M&T Ranch

Waterway			Bank	Unit Miles
Unit No. 01 Murphy Slough at M&T Ranch			Left	0.78
	Spring (March - May)	Summer (June - August)	(September - November) Fall	Winter (December - February)
Unit Maintenance Rating (Fall Only)				
Date of Inspection	04/11/2014 - 04/11/2014			
DWR Inspector	Bob Duffey			
Accompanied By	Jason Cooper Sutter Maintenance Yard

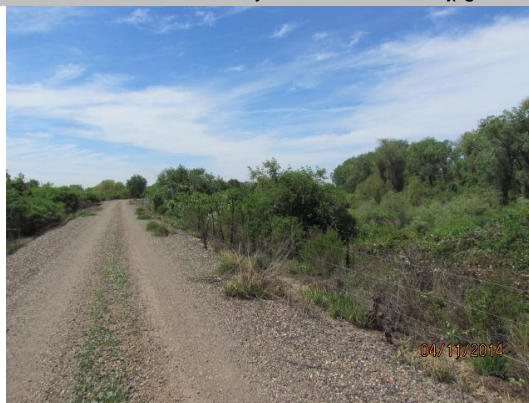
Photo 1 of 1 : rduffey_s_20140428_192.jpg

LM Start	0.00	Rating **	M	Issue No.	1
LM End	0.09	Issue Type +	Ma	Location *	WS
Category	Earthen Levee			GPS Latitude/Longitude	
				Start	End
Item	Vegetation			39.667534 °	39.666836 °
				-121.959612 °	-121.960897 °
DWR ID	DWR_NA0014_01_s _ 2012_1				
Action/Comments					
Elderberries are blocking visibility and flood fight capability.

View of the elderberries along the waterside slope.

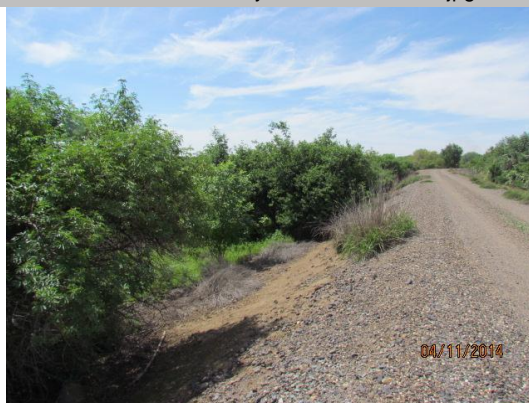
Photo 1 of 1 : rduffey_s_20140428_191.jpg

LM Start	0.00	Rating **	M	Issue No.	4
LM End	0.09	Issue Type +	Ma	Location *	LS
Category	Earthen Levee			GPS Latitude/Longitude	
				Start	End
Item	Vegetation			39.667708 °	39.666983 °
				-121.959817 °	-121.960997 °
DWR ID	DWR_NA0014_01_s _ 2012_4				
Action/Comments					
Elderberries are blocking visibility and flood fight capability.

View of the elderberries along landside toe.

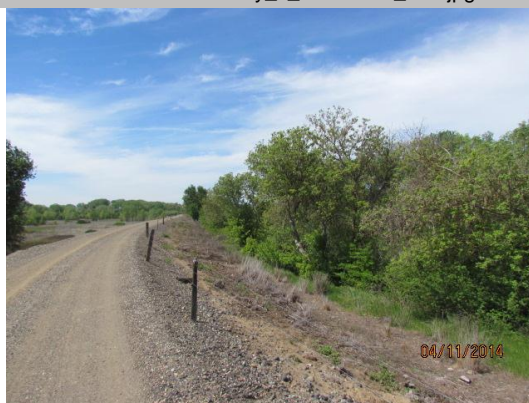
Photo 1 of 1 : rduffey_s_20140428_193.jpg

View of the vegetation along the waterside slope.

LM Start	0.00	Rating **	M	Issue No.	5
LM End	0.20	Issue Type +	Ma	Location *	WS
Category	Earthen Levee			GPS Latitude/Longitude	
				Start	End
Item	Vegetation			39.666988 °	39.666988 °
				-121.960993 °	-121.960993 °
DWR ID	DWR_NA0014_01_s _ 2012_5				
Action/Comments					
Remove the wild growth other than native grasses from the levee slopes.
